## ACX-10 Field Installation and Evaluation Oct 21<sup>st</sup> through Nov 1st, 2002 Silver State and CR England Fleets

Report Date: 05 November, 2002

### Overview

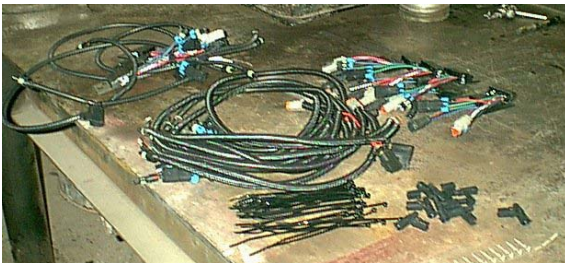
The kits were configured for single wire A/C clutch control, dual wire A/C clutch control, and the single and dual wire installations with data logger only.

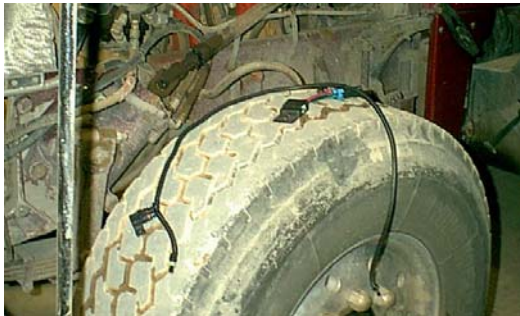
The trucks were rotated through the facility, each requiring 10 to 30 minutes of install time.

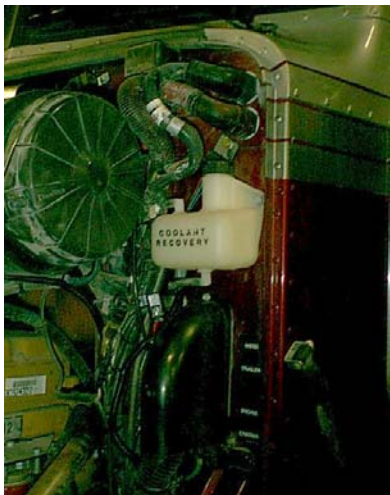
The newer vehicles had more challenges with coolant overflow tanks, accumulators, and other devices in the way of installation, but still the process was relatively easy.

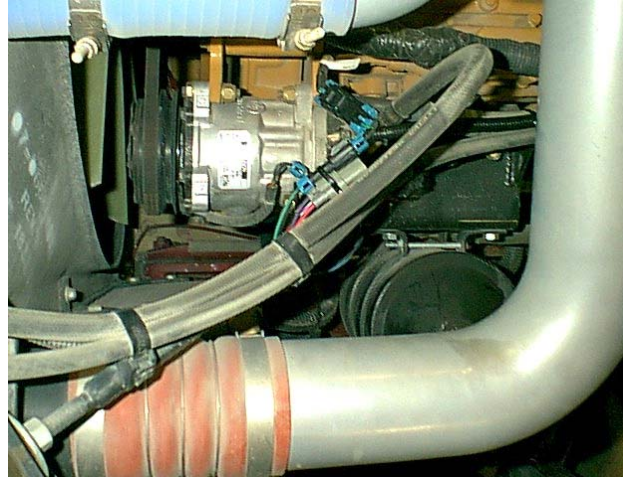
The trucks' vintage varied, as did the brands of A/C compressors and their installed locations. The easiest to work on were trucks with compressors located on the lower drivers side of the CAT 10 liter engines (shown below).

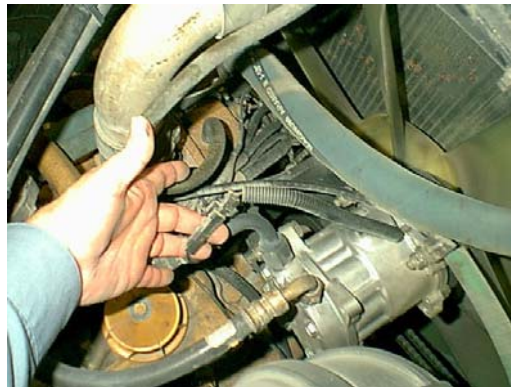
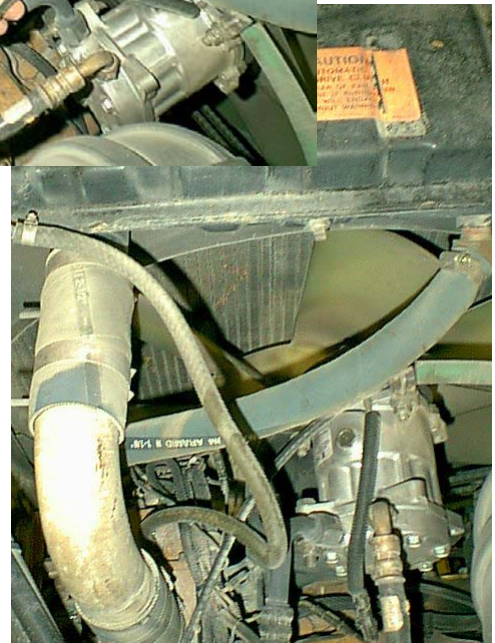
The top mounted version, although still an easy install required more care routing wires and connectors to clear the radiator fan and drive belts.

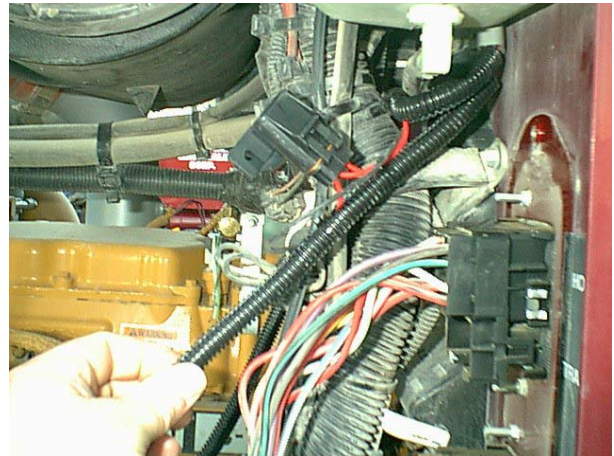
The ACX wire harness is routed to the Cab wire duct:

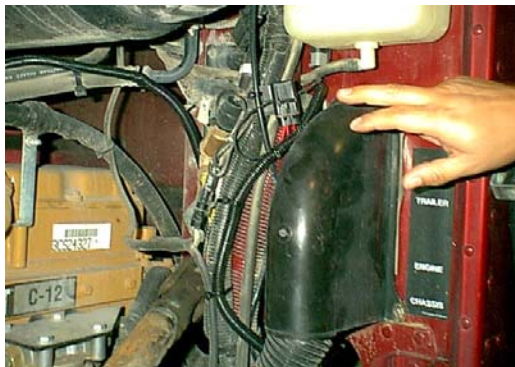
The “cab and truck wire harness” access cover (shown below) provides access to the 12V switched and fused accessory wire that powers the ACX module when the ignition is turned on.

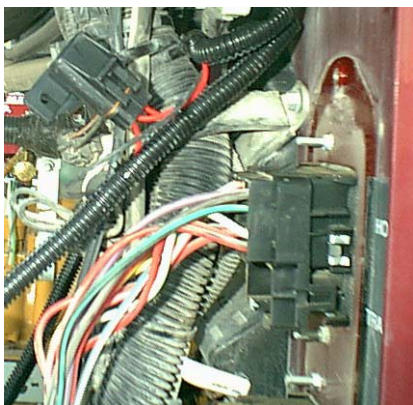
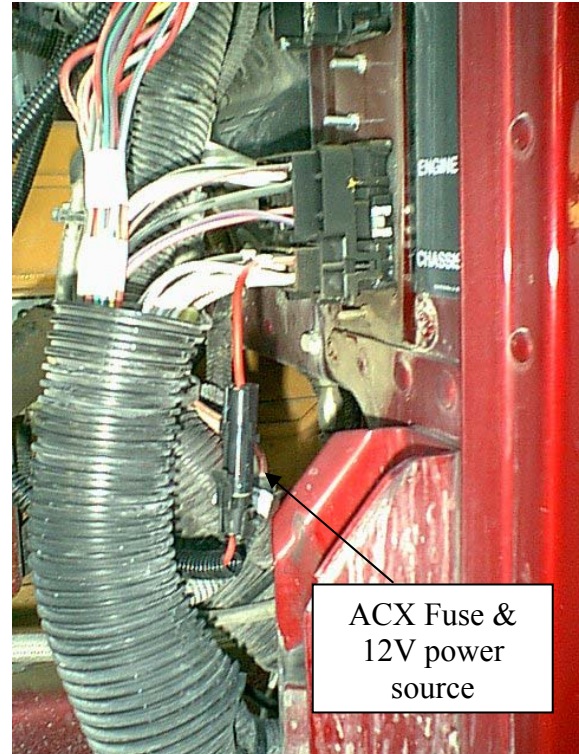
Cab wiring cover is removed:

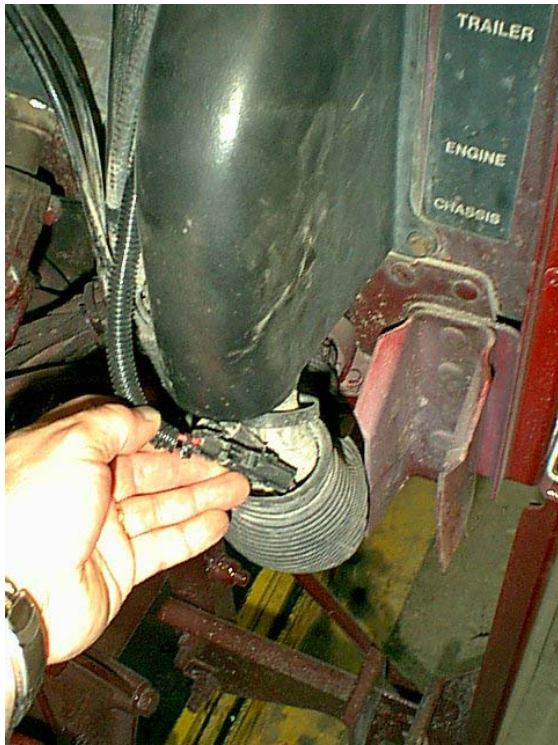
The cab wire access cover is re-installed. Special attention was placed in ensuring the connector was protected from abrasion and zip tied for relief:

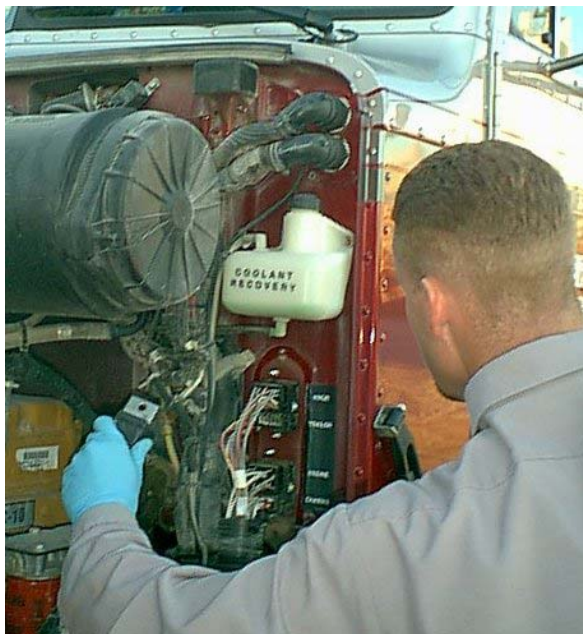
The ACX-10 routed into position:

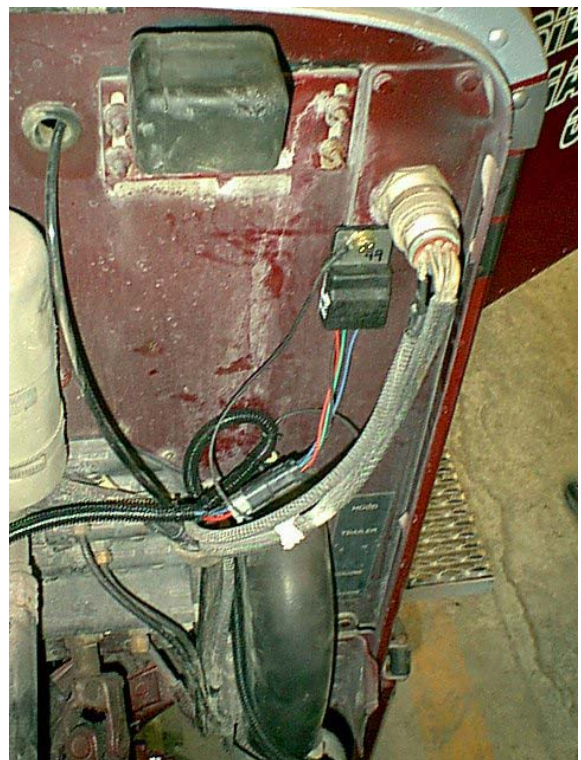
Finished view (truck without coolant recovery tank shown below)

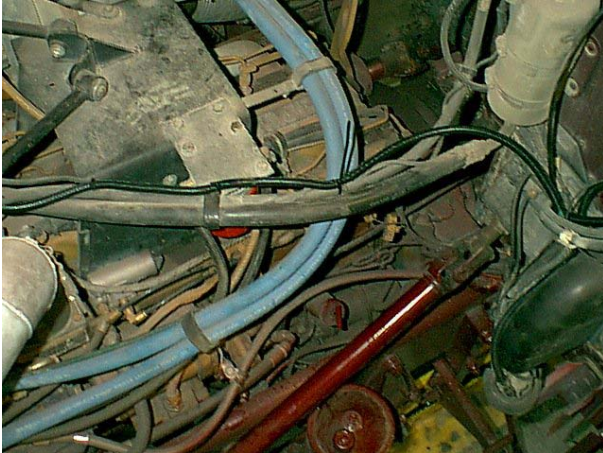
Routing the wires along the A/C hoses secured with Zip Ties©

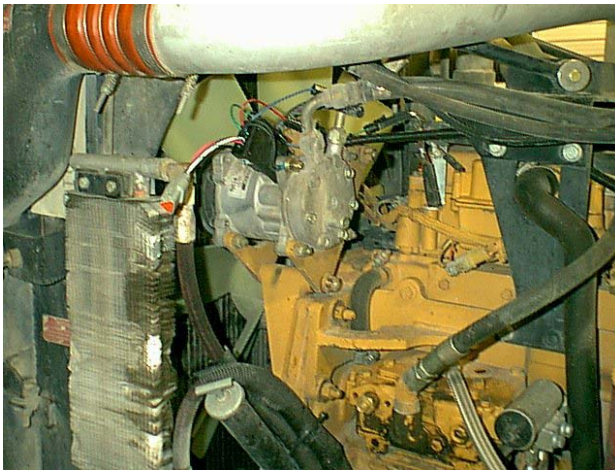
Connection to the A/C compressor included the Index Sensors X-Logger™. The data logger is mounted to a spare compressor mounting lug, including the X-Logger ground wire (when required). The data collection port is shown below and very accessible:

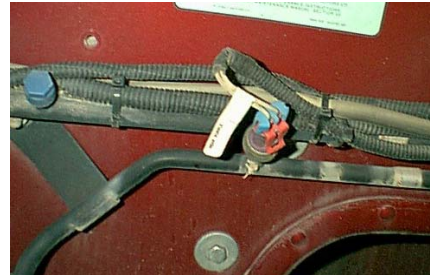
Low pressure Switch:

Although there are not a lot of failures, the switch that does fail is the low pressure side, attributed to the constant cycling of the clutch caused by cyclic pressures.

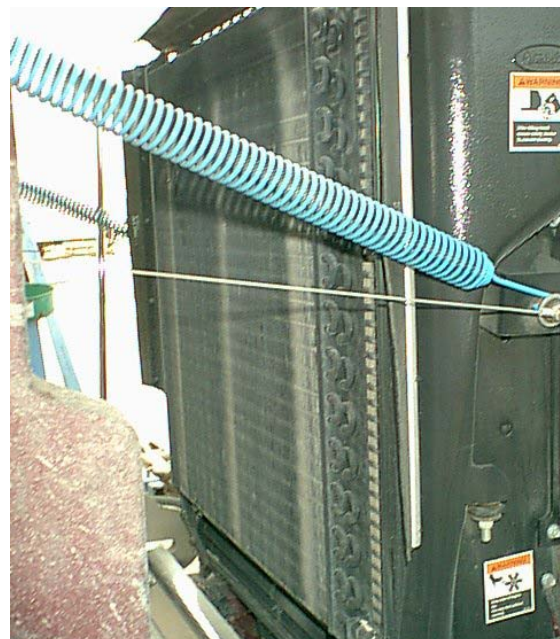
During the evaluation, it was discovered the size of the condenser was oversized when used with the viscous clutch engine fan. Air-driven fans which do not run continuously seem to operate properly.

Since the viscous engine fan basically runs continuously, the refrigerant pressure is never allowed to build and operate efficiently. These systems with large condensers had experienced clutch failures. In trucks utilizing modified condensers with ½ the tubes bypassed (not shown), the systems operated correctly.

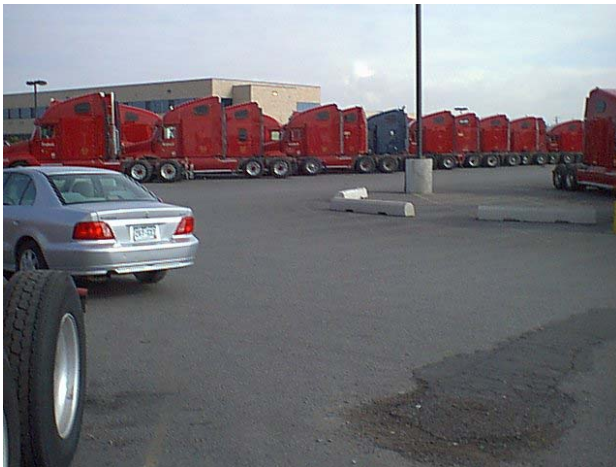
The fleet trucks are located across three areas: receiving, refit, and ready to roll. Covering the few-hundred acre facility looking for trucks was challenging as the trucks may arrive at any time and some trucks are moving from place to place.

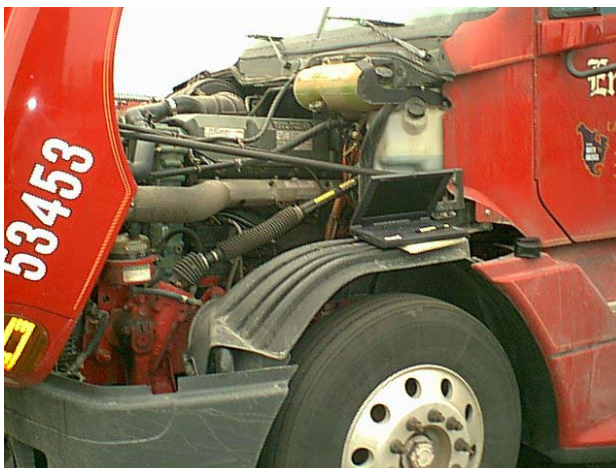
Data from the located trucks were downloaded using a laptop and the X-Logger software:

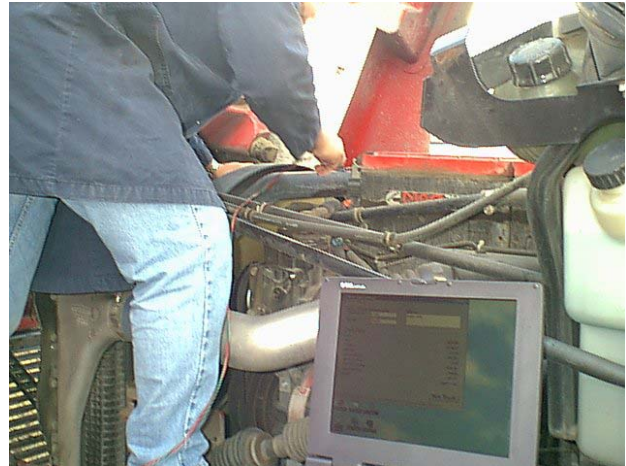
Some of the compressors were located on top the engine which made access more difficult.
